EPA Removal Actions 2010 – 2011

US Oil Recovery Superfund Site, Pasadena TX

PRP Group Removal Actions 2011 – present

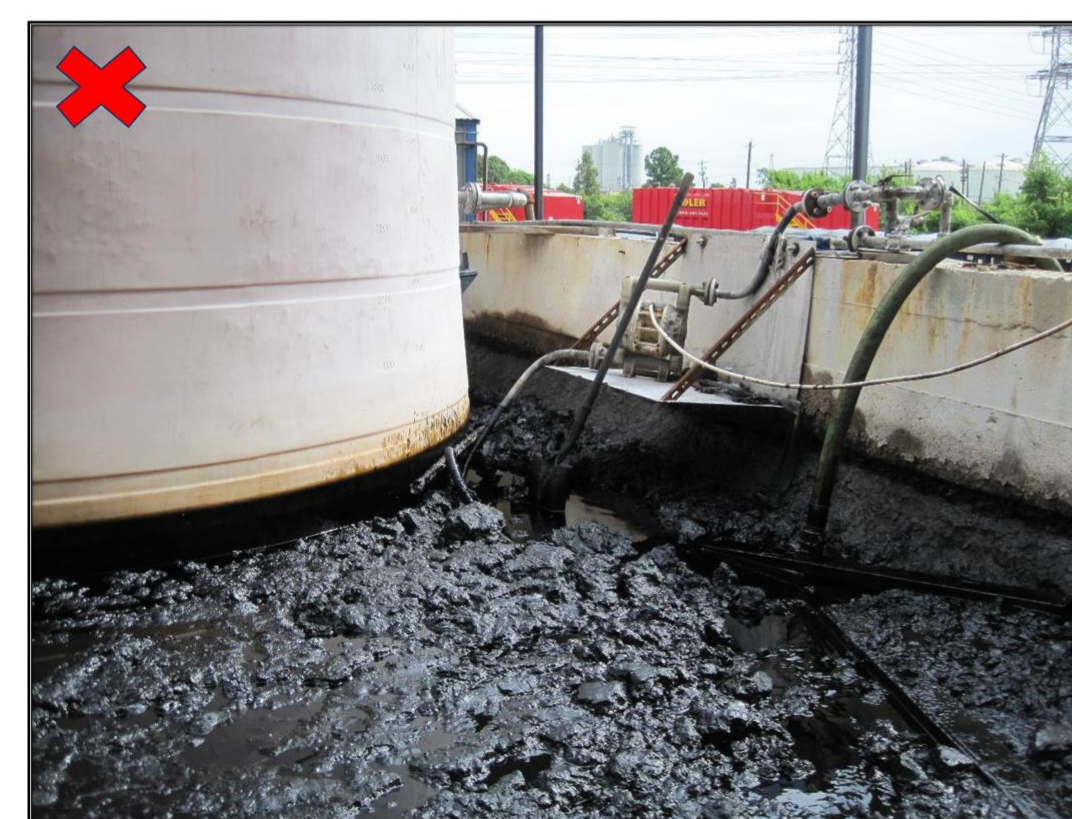
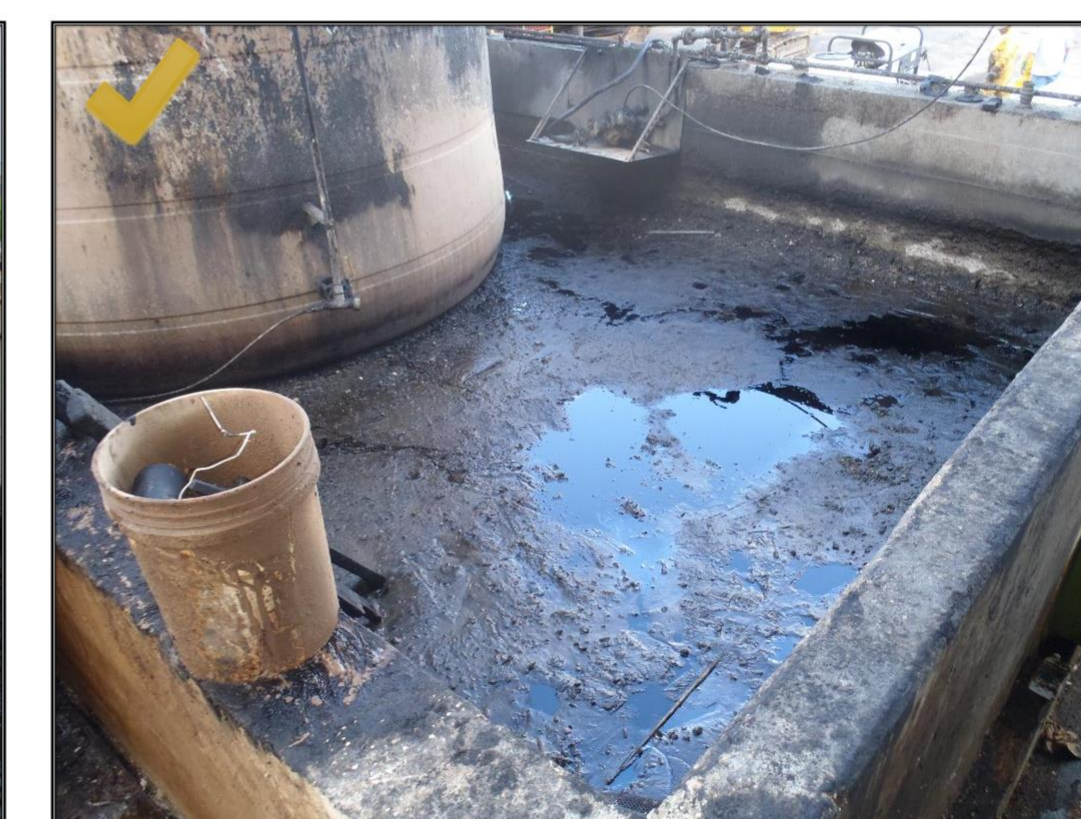
USOR Property – Acid Tank Secondary Containment

✗ The secondary containment for the acid tank (40) deteriorated and leaked oily pH 1 liquid

✓ The tank was removed, contents of the secondary containment were removed, and the corroded concrete leak was repaired

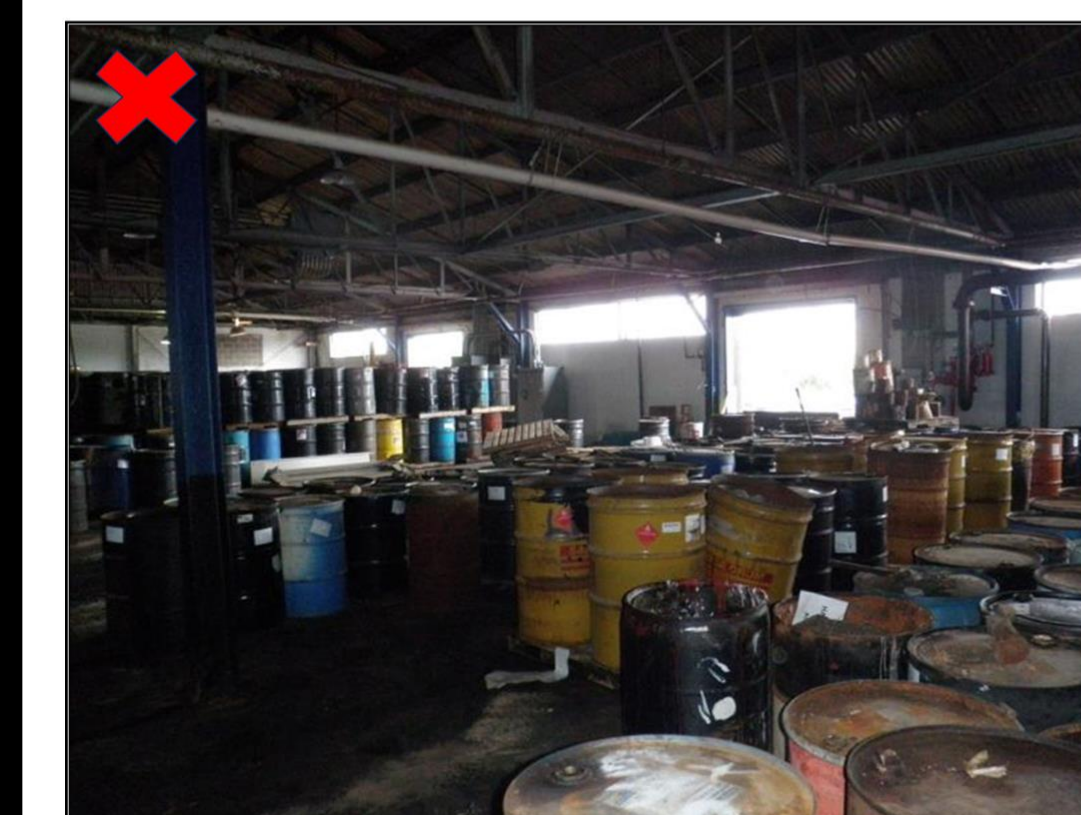
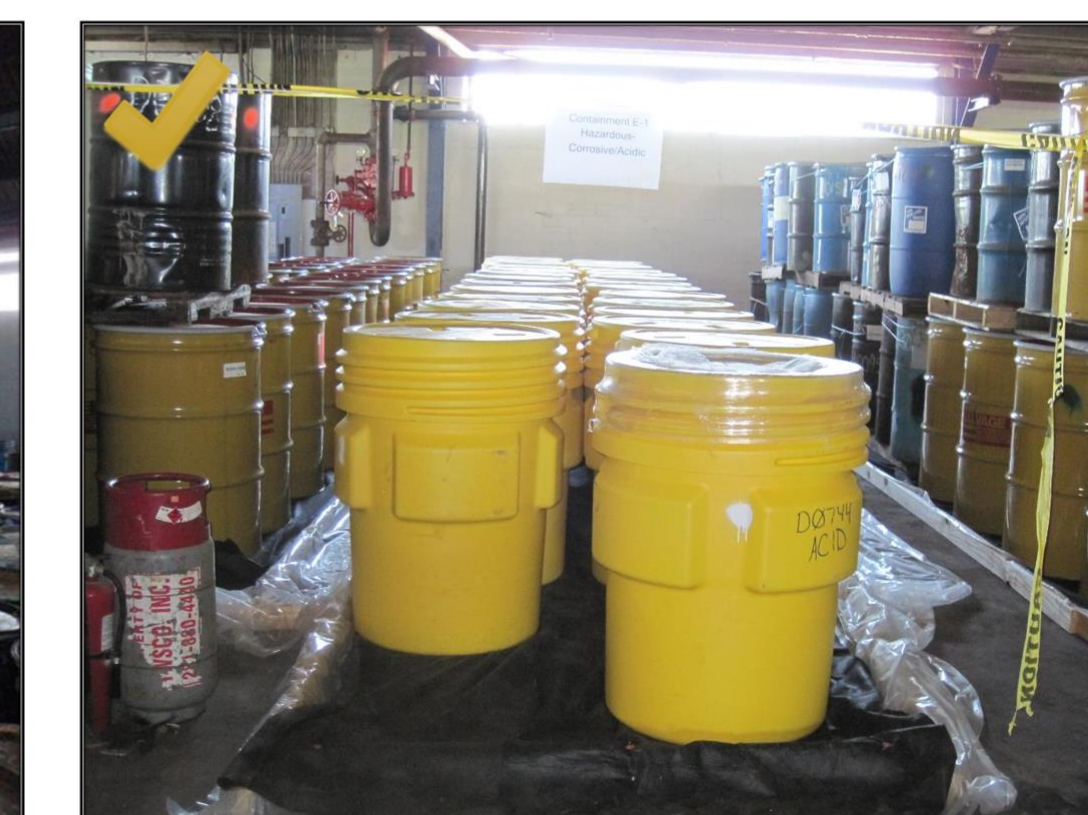
USOR Property – Warehouse Drum Storage

✗ Drums stored in no particular order and inaccurate labels
✗ Incompatibles side-by-side
✗ Corrosives stored in metal drums

✓ Drums were sampled, field screened, stored in appropriate containers
✓ Sorted by hazard characteristics on poly with containment and proper signage

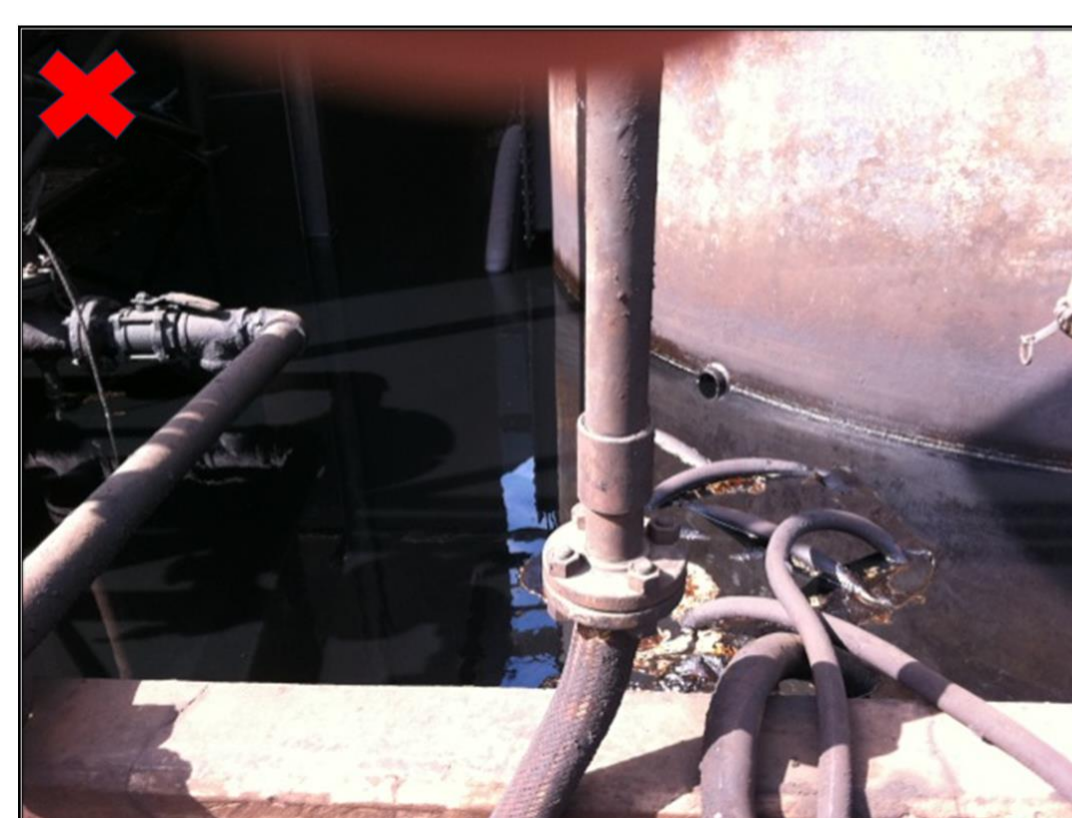
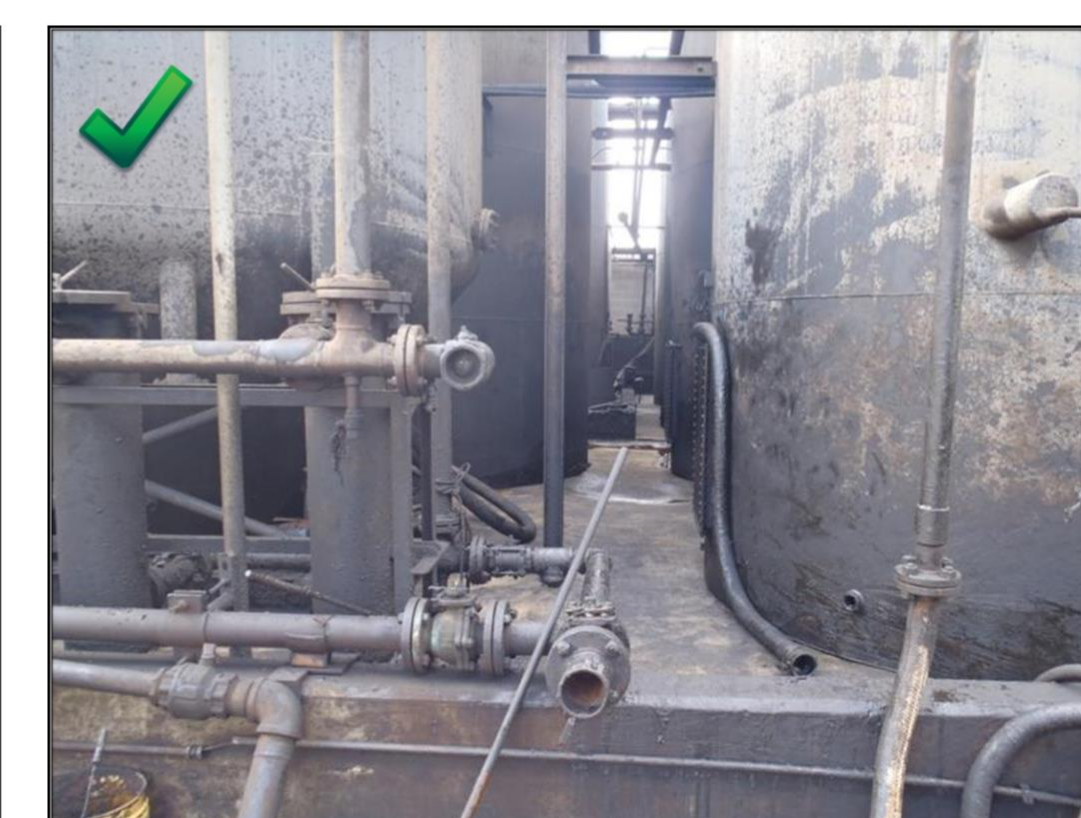
USOR Property – North Tank Farm Secondary Containment

✗ Oily liquids/sludge and high benzene
✗ Signs of overflow on the north and east sides

✓ Emptied and spray washed

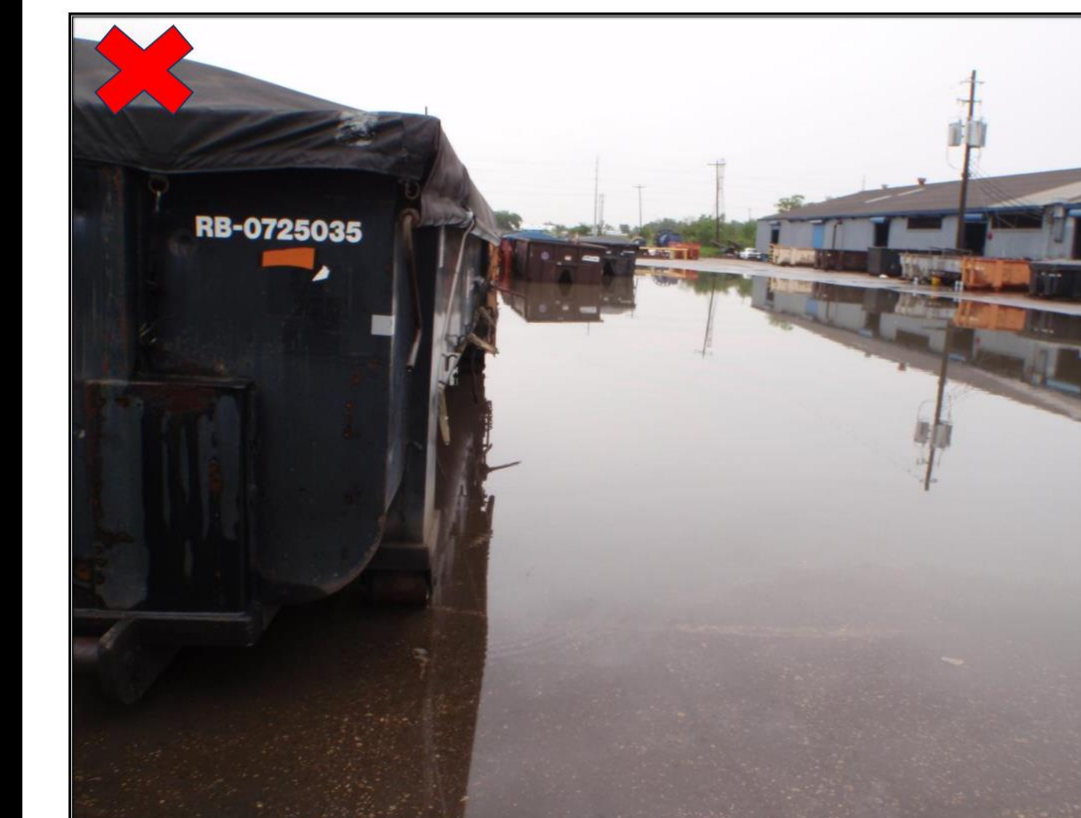
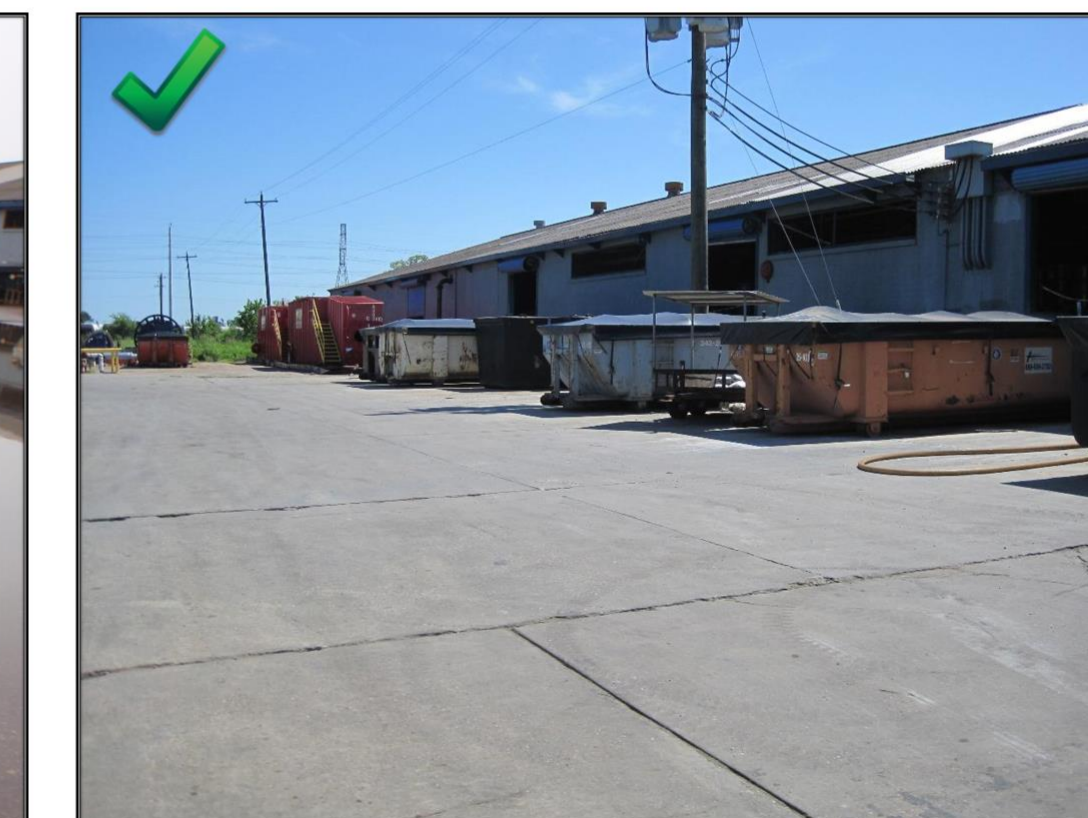
USOR Property – Parking Lot

✗ Containment overflow and storm water in parking lot
✗ During rain overflow into Vince Bayou about 25-50 feet from fence line

✓ Parking lot emptied and spray washed

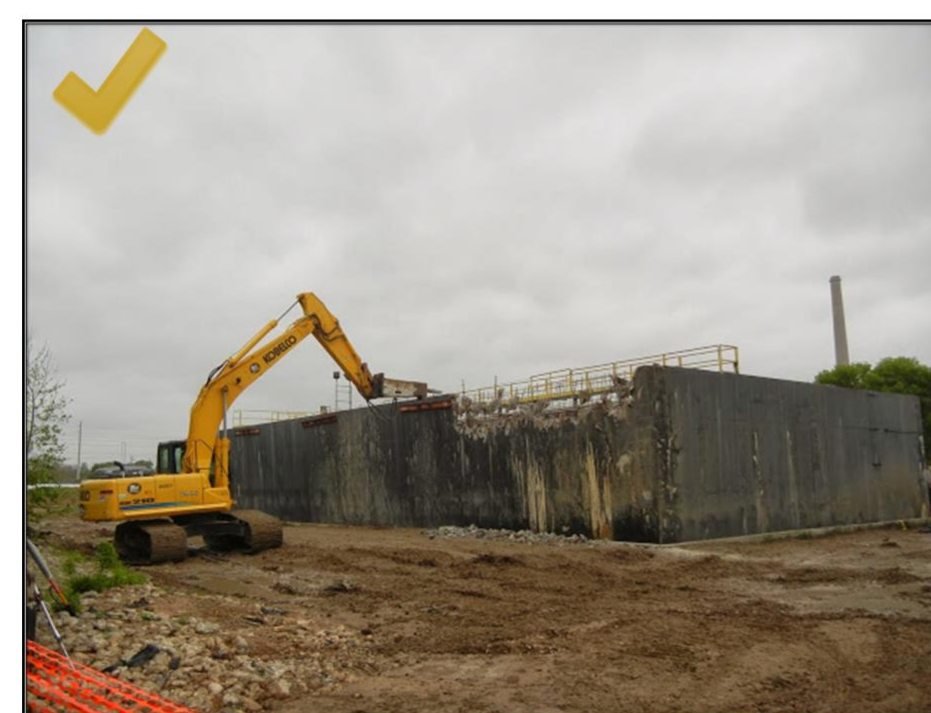
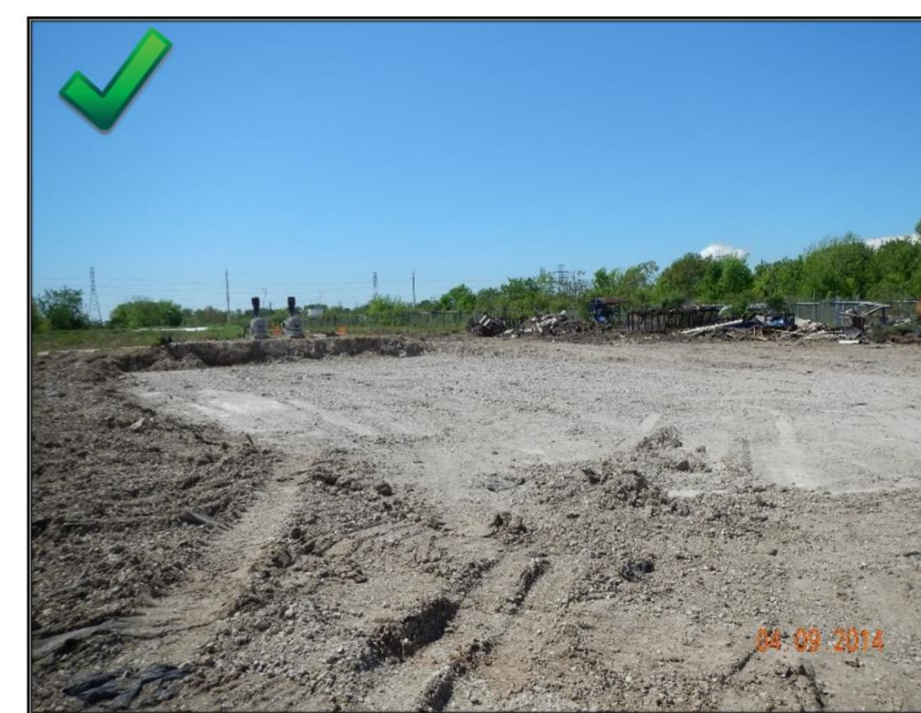
USOR Property – Bioreactor Removal contd.

- Details:**
- 500,000 gal of liquid removed
 - 150,000 gal of slurried solids removed
 - Structure pressure washed and demolished (800 cubic yard debris removed)
 - Sent to permitted disposal facilities

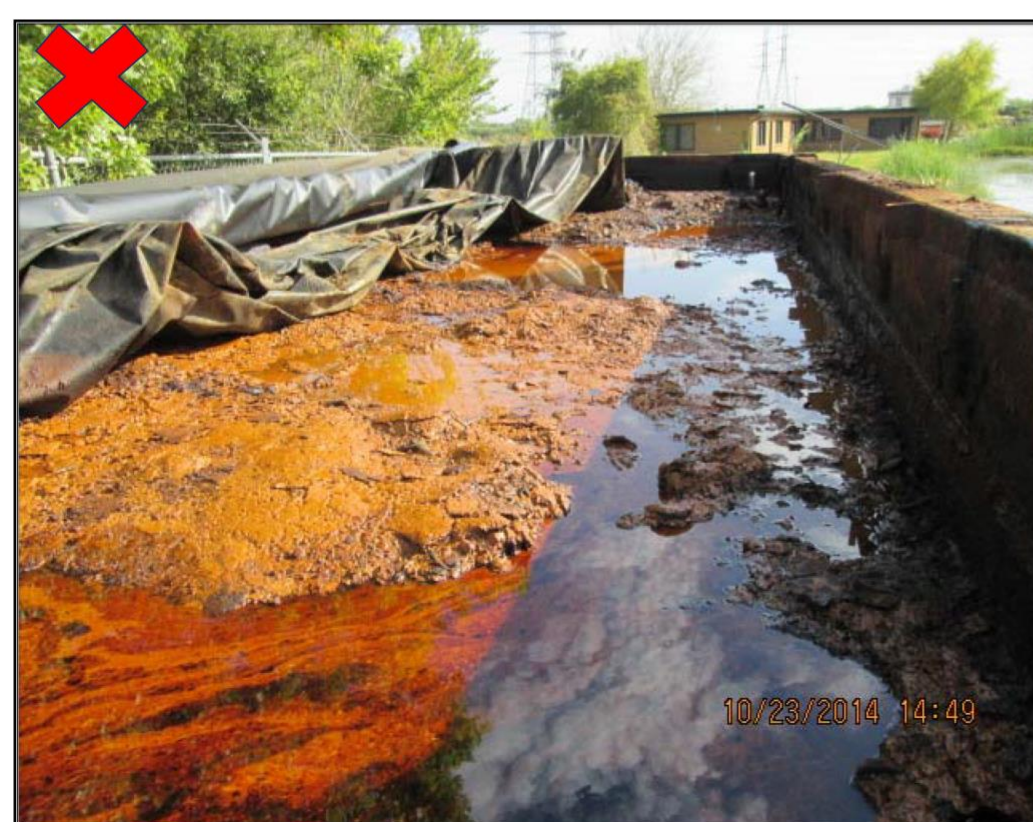
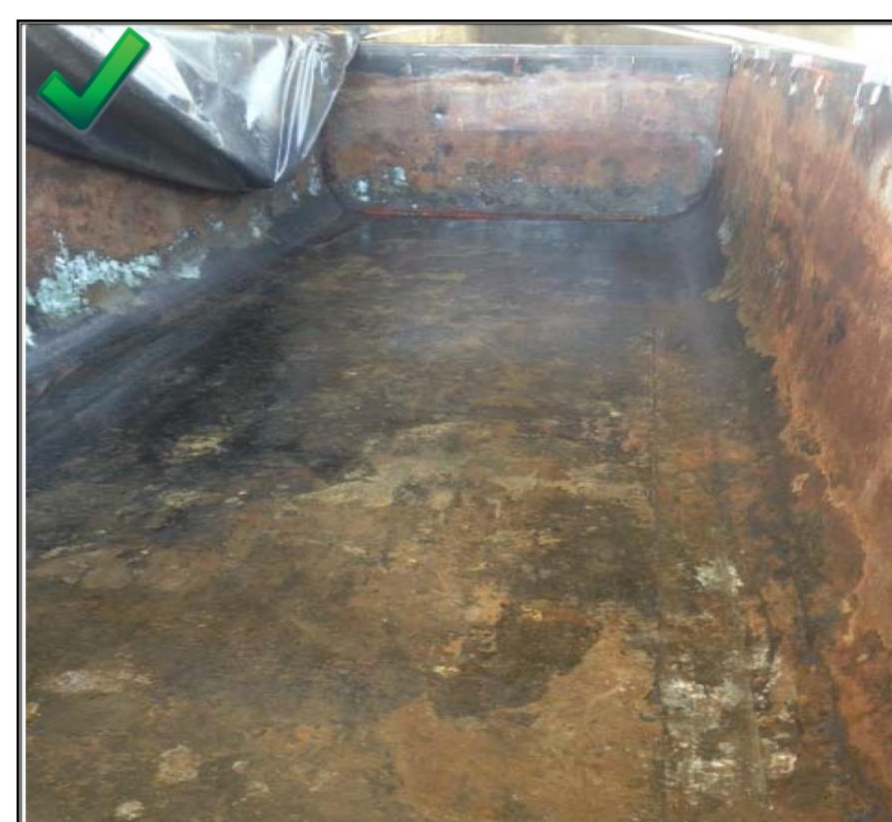
USOR Property Roll-off Boxes August 2013 – March 2015

- 80,000 gal of liquid (not including washout) removed
- 400,000 gal of solids (including cutter) removed 600 tons of nonhaz solids (including ash)
- 100 tons haz solids from Frac tank removed

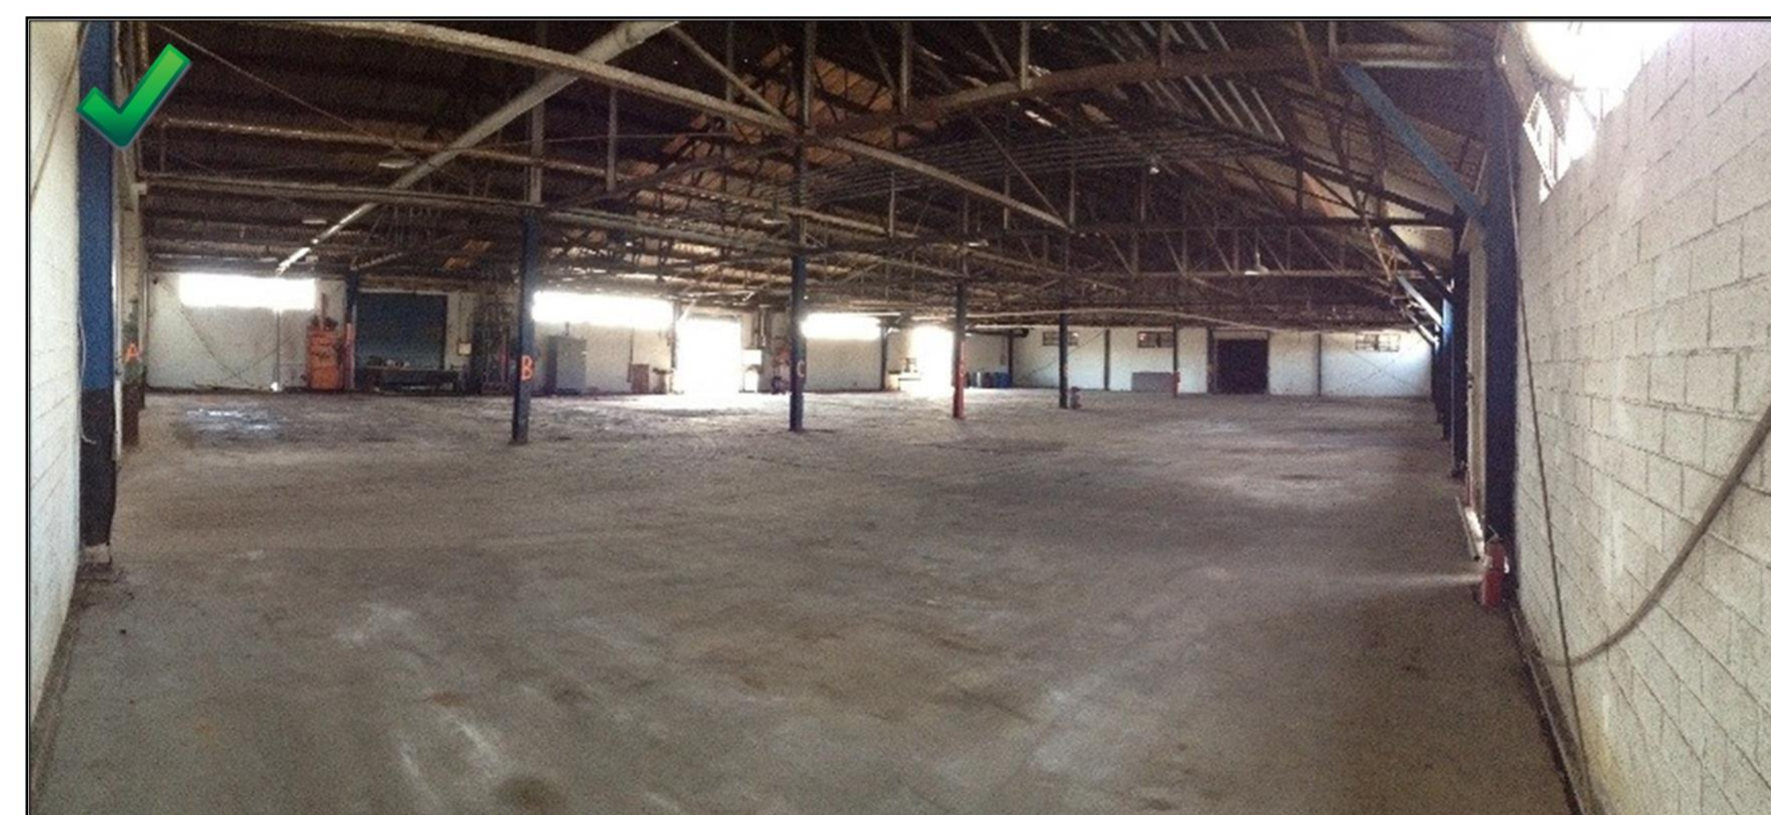
USOR Property – Emptied Warehouse March 2014 – January 2015

- ✓ Approx 1,107 containers (drums and totes) removed;
- ✓ Approx. 28,000 gal of container contents shipped in bulk for disposal

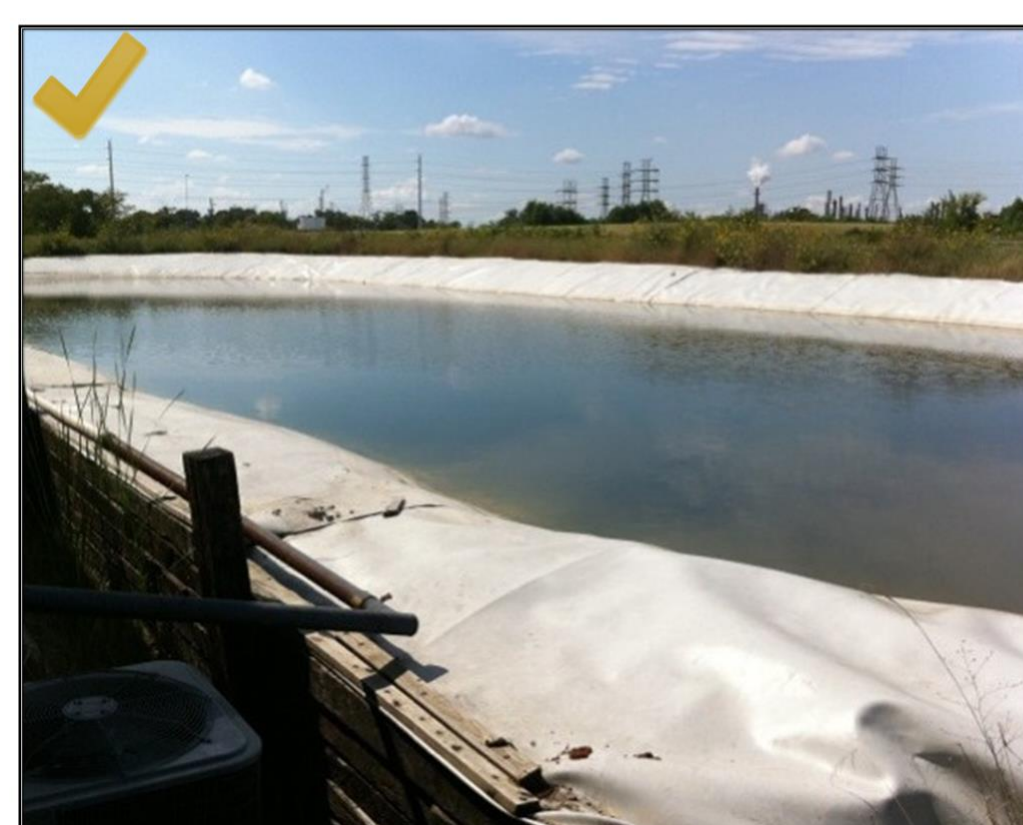
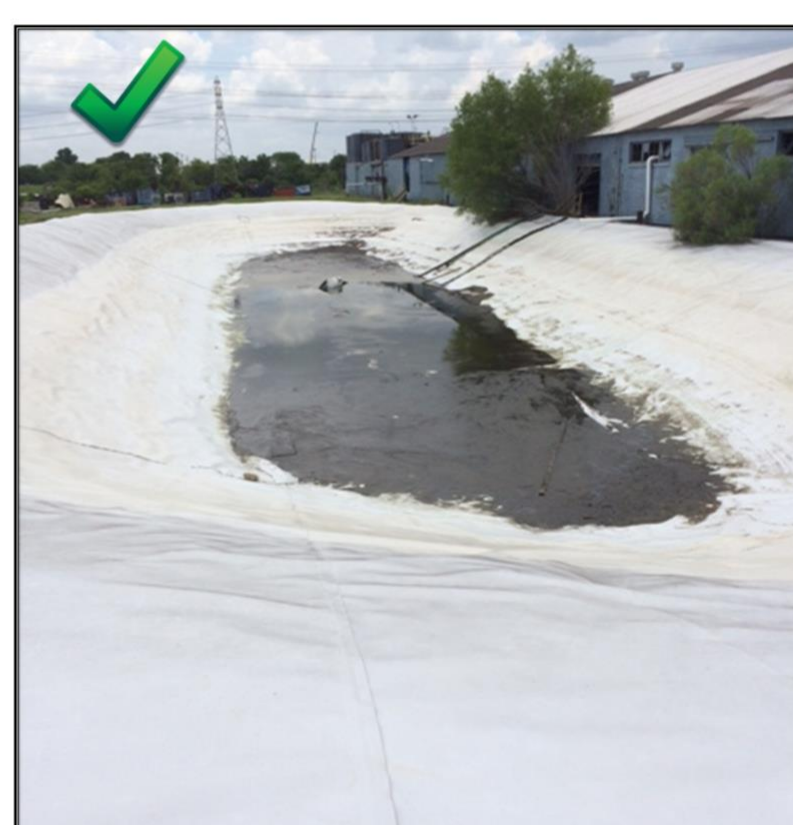
Containment Pond Drawdown Dec 2013 – Jan 2016

- Drawdown of 1,400,000 gal of storm water
